# Manhole Inspection Summary

Manhole # S51II\_034MH

Insp Date: **8/1/08 9:06 AM**

**Location** Address: **Kenhill**

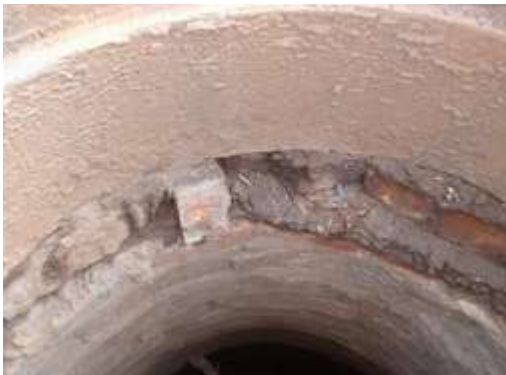
Defect 1

Condition: ☐ Sound ☐ Cracked ☐ Root Intrusion ☒ **Loose Brick** ☐ Deteriorated

Loose brick

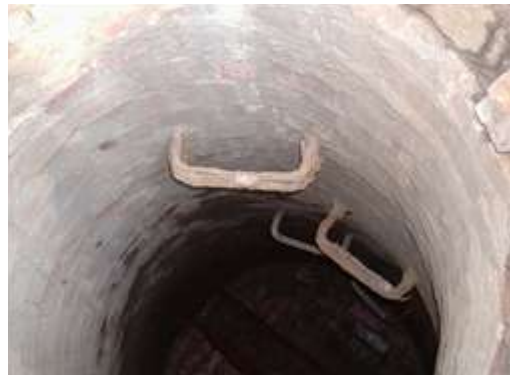
Defect 2

Infiltration: ☐ None ☐ Joint ☐ Cracks ☒ **Mortar** ☐ Roots ☐ Wall

Infiltration

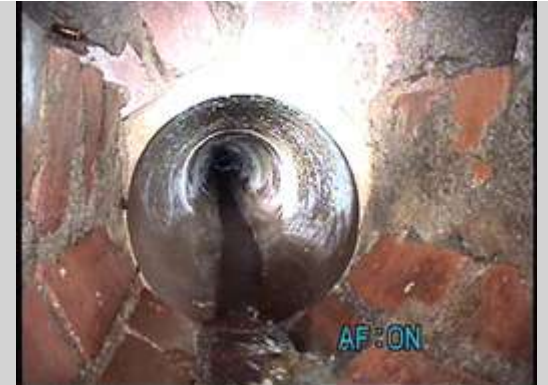
12 O'Clock Outflow

8 in. Circular Gravity Sewer  
Pipe Out @ 12 O'Clock

Pipe Height: **8.4** (in.) Rod and Bar (Angled)  
Pipe Material: **Clay** ☐ Pipe Lined  
Invert Depth: **10.30** (ft.) Flow Characteristics: **Fast**  
Deposits: ☒ None ☐ Mud ☐ Sludge ☐ Debris ☐ Grease  
Silt Depth: (in.) Deposits Extent:  
Infiltration: **None** Pipe Seal Cond: **Sound**

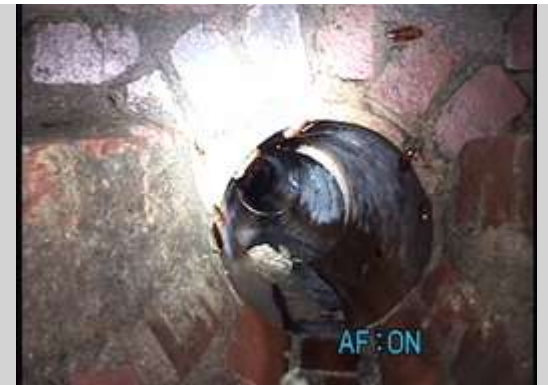
3 O'Clock Inflow

8 in. Circular Gravity Sewer  
Pipe In @ 3 O'Clock

Pipe Height: **8.4** (in.) Rod and Bar (Angled)  
Pipe Material: **Clay** ☐ Pipe Lined  
Invert Depth: **10.10** (ft.) Flow Characteristics: **Fast**  
Deposits: ☒ None ☐ Mud ☐ Sludge ☐ Debris ☐ Grease  
Silt Depth: (in.) Deposits Extent:  
Infiltration: **None** Pipe Seal Cond: **Sound**

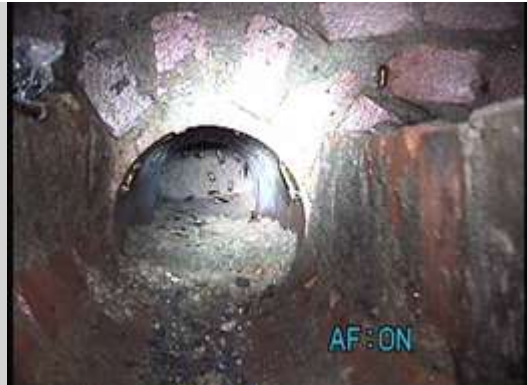
6 O'Clock Inflow

Infiltration: **None** Pipe Seal Cond: **Sound**
